Transport and Environment Committee

Response to Motion by Councillor Booth - Rainbow Bridge/Lindsay Road Bridge

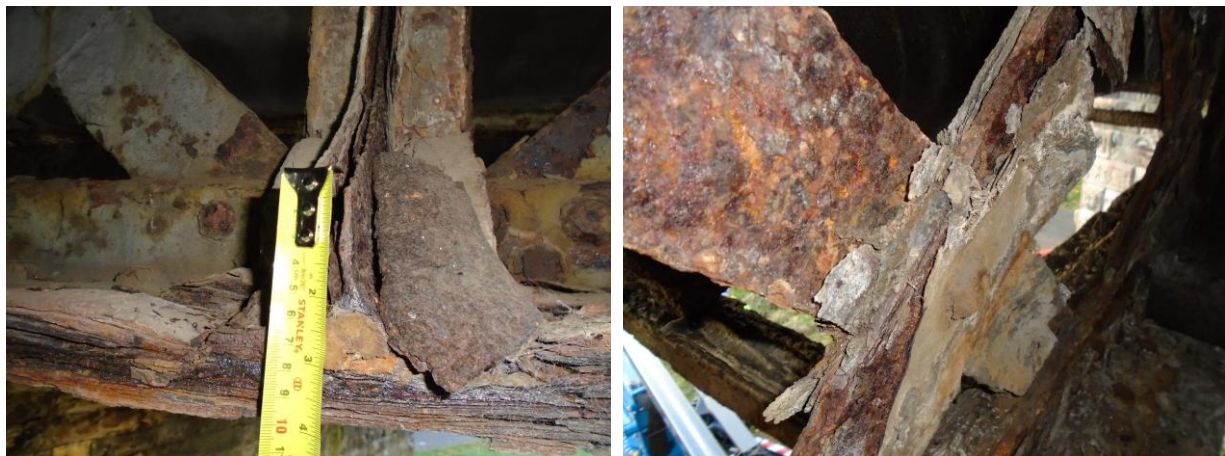
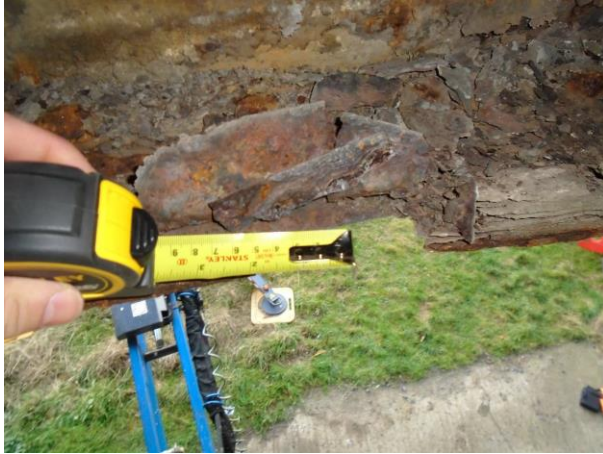
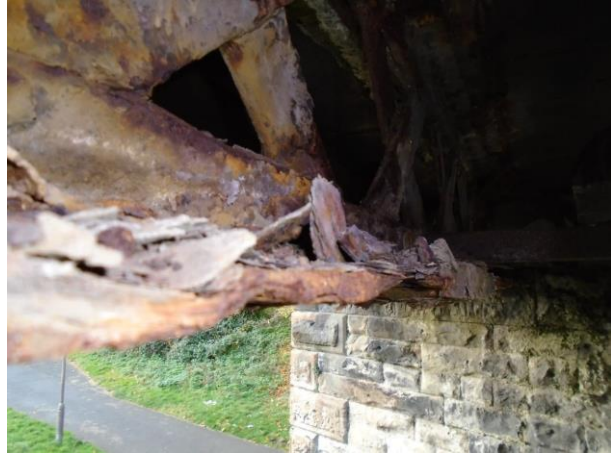
- 3.6 Lindsay Road Bridge was found to be in poor to very poor condition, with span 2 noted to be in the worst condition. Spans 1 and 3 are serviceable but poor condition and there are safety concerns due to the very poor condition of span 2.

Repair of span 2 would involve removing corroded steelwork, welding or bolting replacement pieces, and repainting. The Council regularly undertakes this type of repair work on structures, however the extensive areas of corrosion and section loss, combined with the intricate nature of the steel lattice beams, means that this option is not feasible.

Condition of span 2 lattice structure renders repairs unfeasible

Therefore this option has been discarded as it is technically unfeasible.
