Subject: Re: Tree advice 19 Inveralmond Drive

TD Tree & Land Services Ltd have been instructed by Mr. Gregory Favier to carry out a survey at 19 Inveralment Drive, Edinburgh, EH4 6JX and produce a report on the Arboricultural impacts in accordance with British Standard BS:5837 Trees in relation to Design, Demolition and Construction – Recommendations.

Tree Survey

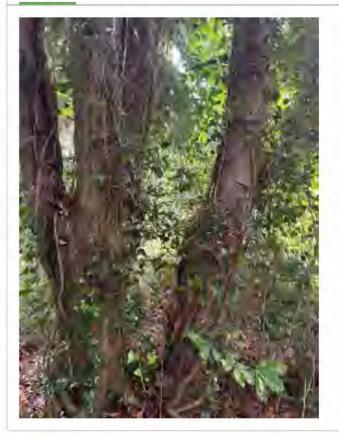
Sycamore Tree ID #5 20 Avon Road

lvy covering stem, eastern stem showing large section of decay at base up to approx 2m height

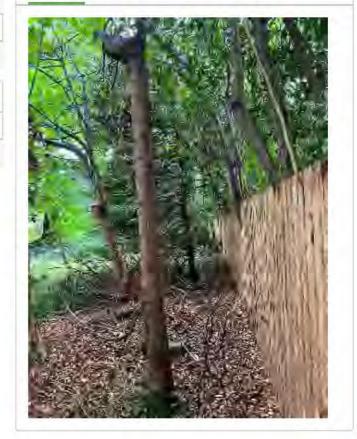
Leylandii Tree ID #13

Tree T13 is a standing dead habitat pole, however, due to site safety, its removal is recommended. The stem may be cut up to form a dead wood pile on site, to still serve as habitat for a variety of species.

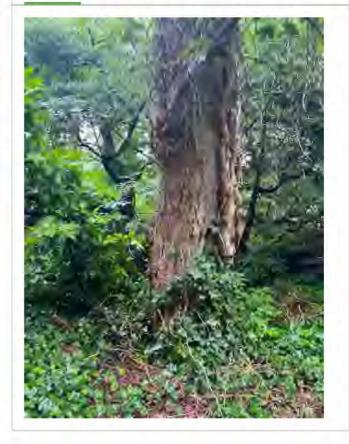
Sycamore Tree ID #22

decay at base

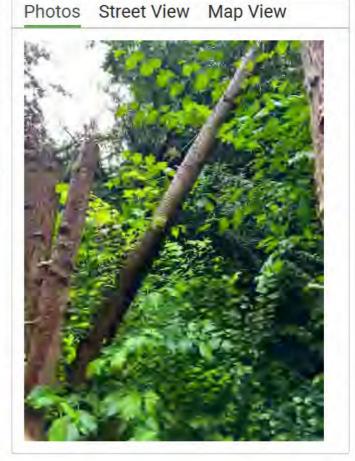
Latin Name:	Tilia x europea
Tag Number:	
Stem Diameter [mm]:	431.86
Priority:	
Comments:	pronounced lean, no signs of compensation for this
Recommendations:

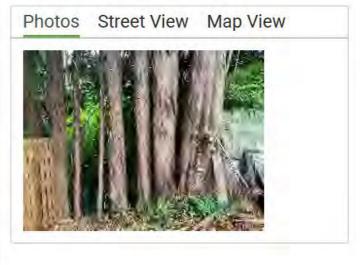
Group ID #1

Tree group G1 is a group of leylandii forming an overgrown hedge. Due to lack of management apart from crown-lifting to create clearance of approx. 3m in height on site, no works have been conducted. The most eastern stems are in direct conflict with the existing wall, and damage to both trees and the wall was observed. Due to their proximity to the house and the lack of management in the past, it is recommended to remove these specimen and replant elsewhere on site with more appropriate species.

Group Details	
Common Name:	Leyland cypress
Life Stage:	Semi-mature
Condition:	Fair
Estimated Remaining Contribution:	Short (10 to 20 years)
Quality Category:	С
Recommendations:	
Comments:	group of leylandii, partially in conflict with adjacent wall,

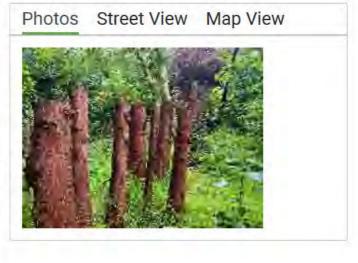
Group ID #2

Group G2 are throughout topped leylandii monoliths, standing at approx. 1.5m to 2m height. Their removal and replacement with appropriate species is recommended.

Group Details		
Common Name:	Leyland cypress	
Life Stage:	Early-mature	
Condition:	Poor	
Estimated Remaining Contribution:	Short (10 to 20 years)	
Quality Category:	С	
Recommendations:		
Comments:	group of leylandii stems felled at approx. 1.5m height, stems

left without foliage
