## New Calton Burial Ground watchtower – proposals for repair and reuse

Appendix 1 New Calton Burial Ground watch tower condition survey and options for future re-use (June 2023)

### **New Calton Burial Ground Watch Tower Condition Survey and Options for Future Re-use**

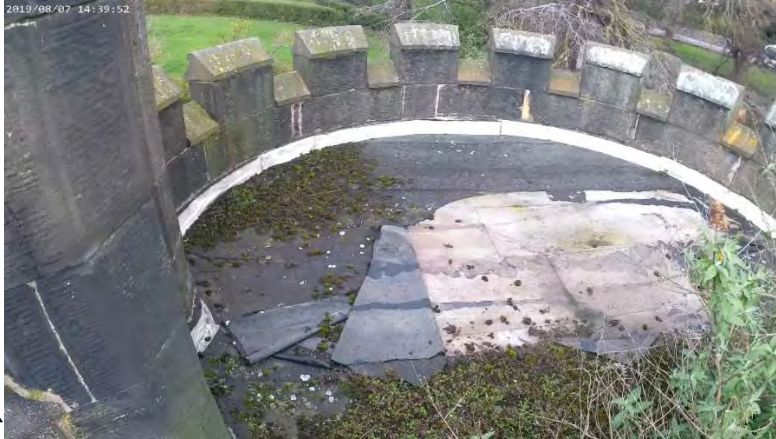
1

- 2.4 Roof coverings and abutments to the Watch Tower and adjacent outhouse are in poor condition. The temporary works carried out in 2013 on the Watch Tower have failed allowing dampness to penetrate the timber roof structure and masonry walls below. The bituminous felt covering should be patch repaired in the short term with complete replacement of the roof structure and new lead roof covering and abutment flashings allowed for in a larger package of long-term fabric repairs.
- 2.5 The outhouse roof has slipped and damaged slates, and failing mortar skew fillets where the roof abuts surrounding masonry walls. Short term repairs should be implemented as soon as possible, with full reslating and new mortar fillets, incorporating leadwork beneath, programmed in future.

Failing felt roof covering and flashband abutment. Failing joints to inner face of parapet.

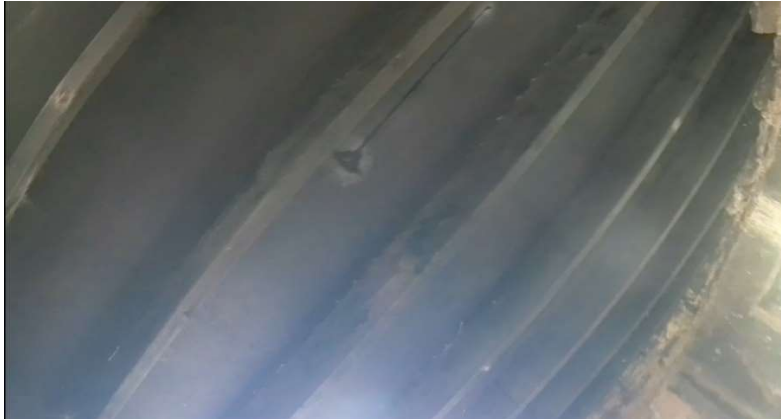
2

Damp stained timbers below failing roof covering.

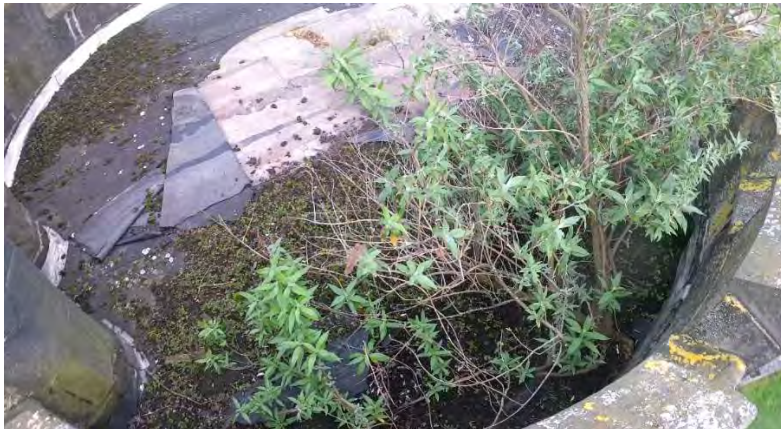
3

- 2.6 The outlet from the flat roof on the Watch Tower is blocked by vegetation and tree growth causing rainwater to penetrate inner facing masonry below. The lead connection pipe from the flat roof stops short of the downpipe. There are localised cracked and damaged sections of cast iron work to the downpipe and wastewater pipe. Decoration is poor. Vegetation and tree growth should be removed as soon as possible. Thereafter, the lead pipe connector should be replaced at the same time as the roof coverings and consideration given to introducing a cast iron hopper at the head of the downpipe to improve flow. A full overhaul of all cast iron pipework and replacement of damaged sections is required prior to complete decoration. Remove the waste pipe if future occupation not anticipated. A CCTV survey of underground pipework, with clearing works as required, should be carried out.

Blocked rainwater outlet from flat roof.

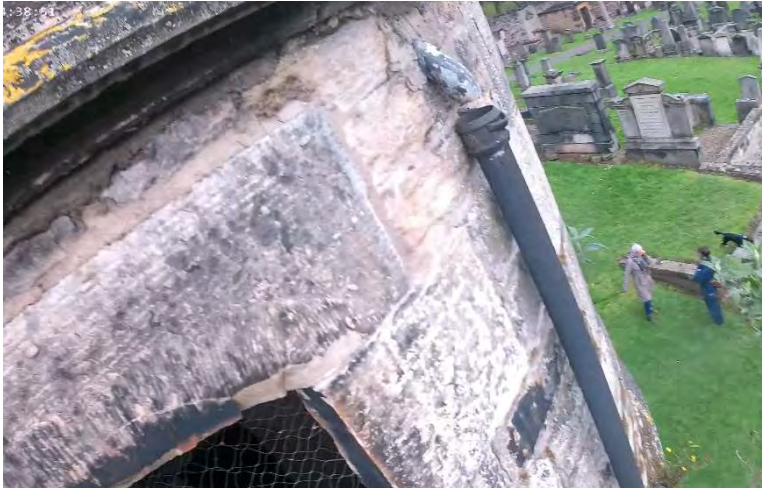
4

Lead pipe between the flat roof outlet and downpipe stops short. Consider introducing a hopper to improve flow.

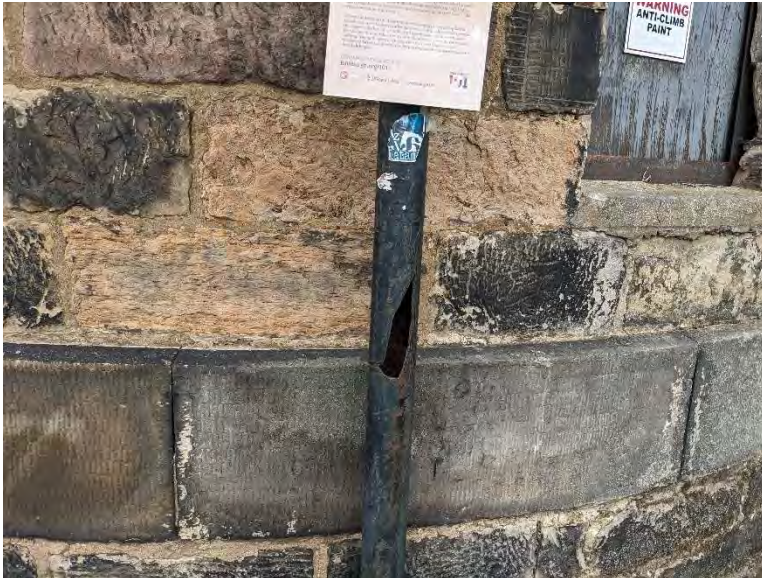
5

Broken waste pipe.

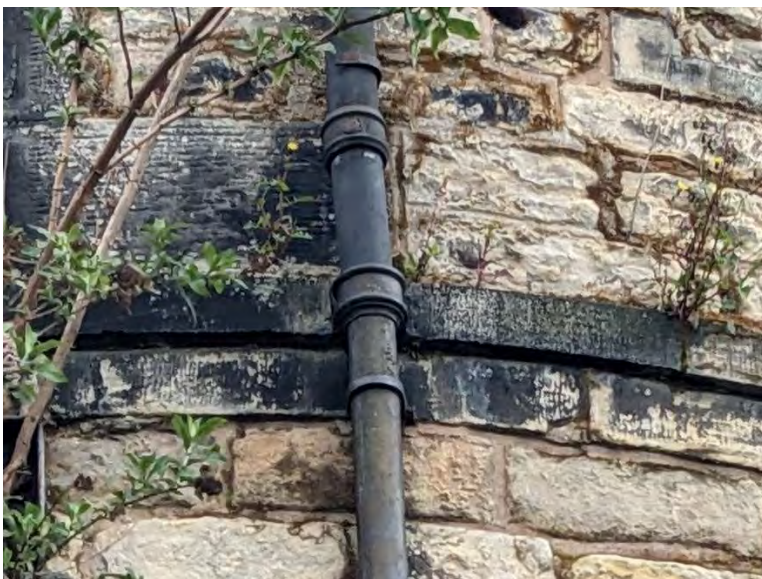
6

Cast iron waste and down pipes are broken, misaligned and in poor decorative condition.

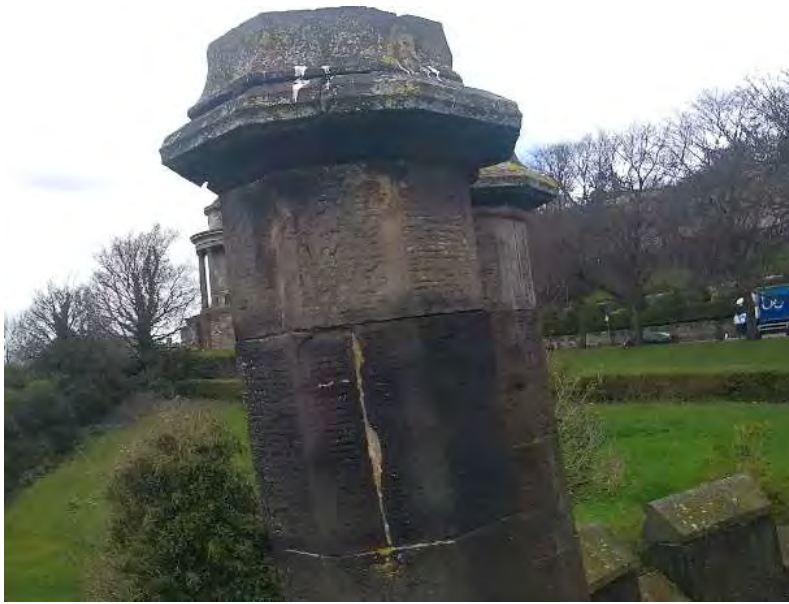
7

- 2.8 The two octagonal ashlar stacks and linked projecting copes are in poor condition with badly eroded and cracked stonework and failing joints visible. Assume dismantling down to parapet cope level and reconstruction with allowance for replacement stonework for damaged masonry to copes and stacks. Introduce discreet vented caps to flues. Allow full repointing on inner face below parapet level with an appropriately specified lime based mortar.

**Open joints to chimney.**

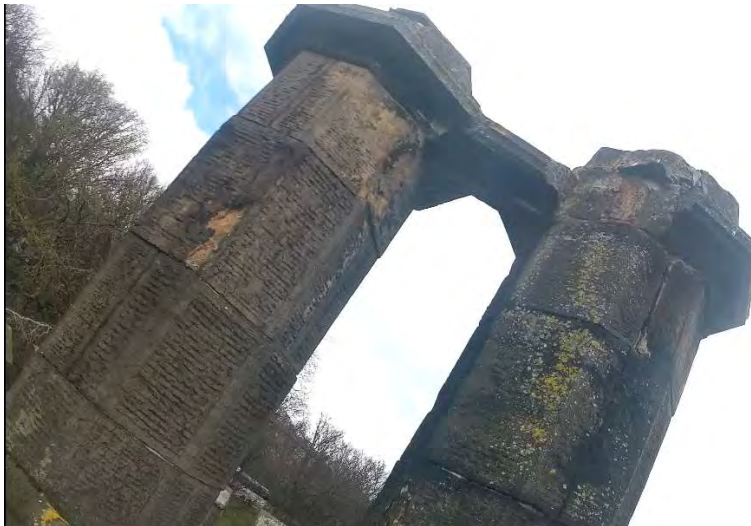
8

**Eroded and damaged to chimney stacks and cope.**

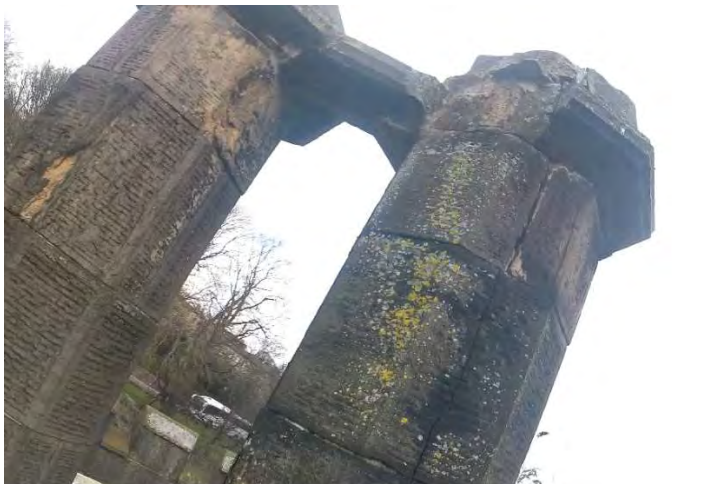
9

**Cracked masonry to stack.**

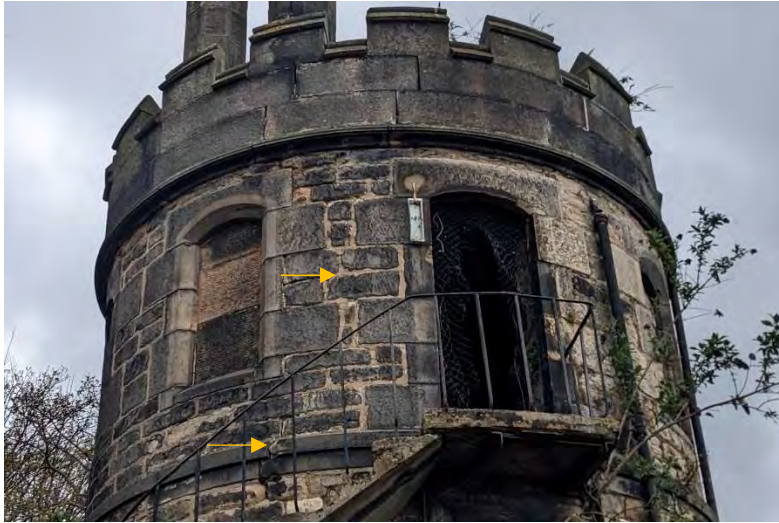
10

- 2.9 The external masonry of the Watch Tower is generally in poor condition. There is movement cracking on the southwest face just below second floor string course extending upwards through the rubble work, uppermost string course and parapet, which has displaced masonry. There does not appear to

be any corresponding cracking visible internally, however close-up observation of the internal faces of the walls was not possible, there not being any upper floors surviving. This movement is obviously connected with the layout of the fireplaces at 1<sup>st</sup> and 2<sup>nd</sup> floor levels and their associated flues, all of which are located in this single panel of wall between window openings. There is damaged and eroded ashlar work to most openings and locally to string courses, and a cracked first floor cill. Localised eroded and damaged rubble work, appears exacerbated by high internal ground levels (possibly from accumulated debris in the solum) and the use of overly strong repointing mortars. Vegetation/tree growth on the south face immediately below the second floor entrance landing. Failing mortar joints throughout.

A structural crack (indicated) to the left of the second floor entrance follows the flues extending from below the string up and through the parapet wall. This crack follows the disposition of the fireplaces in the building (one fireplace at each floor level, set one above the other) and flues running up from them. see also Photo 31

- 2.10 Some low-key structural intervention within the areas affected by the movement described above will be needed. This intervention will range from stitching across cracked stonework and deep-pointing open joints to resetting of displaced parapet masonry with additional metal cramps. Full repointing on both sides of parapet wall is required, with provision for rebedding of copes. Elsewhere, badly damaged stonework should be replaced/indented and all masonry brushed down and descaled prior to filling cracks and repointing failing joints in an appropriately specified lime based mortar.
- 2.11 Similar repairs are required to the lean-to extension to make good damaged masonry around the door opening and repoint failing joints. The small section of timber that surmounts the east elevation masonry should be replaced.

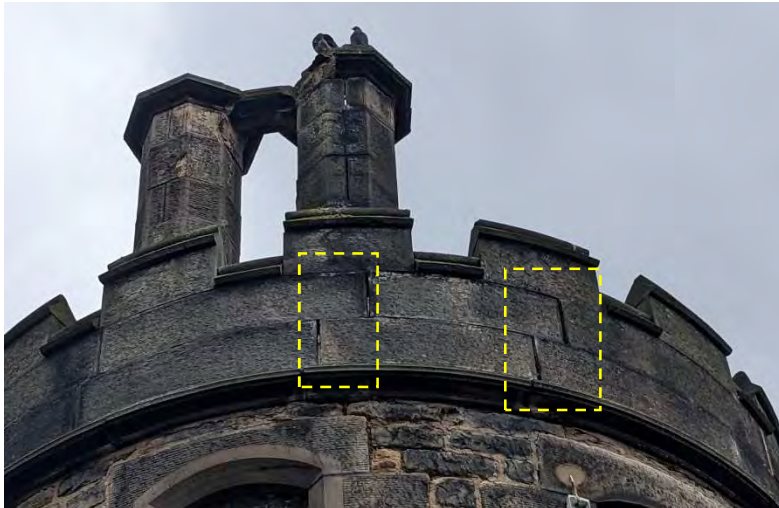
11

Displaced masonry and open joints to the parapet (indicated).

Whilst there are a few cracks and locations of displaced joints, they all have the same root cause (see Photo 10), and are essentially a single feature.

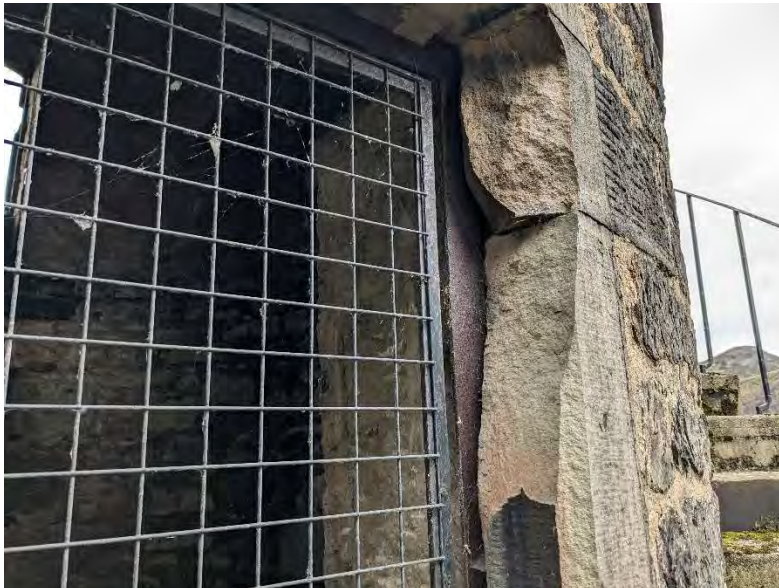
12

Damaged masonry surrounding the first floor entrance.

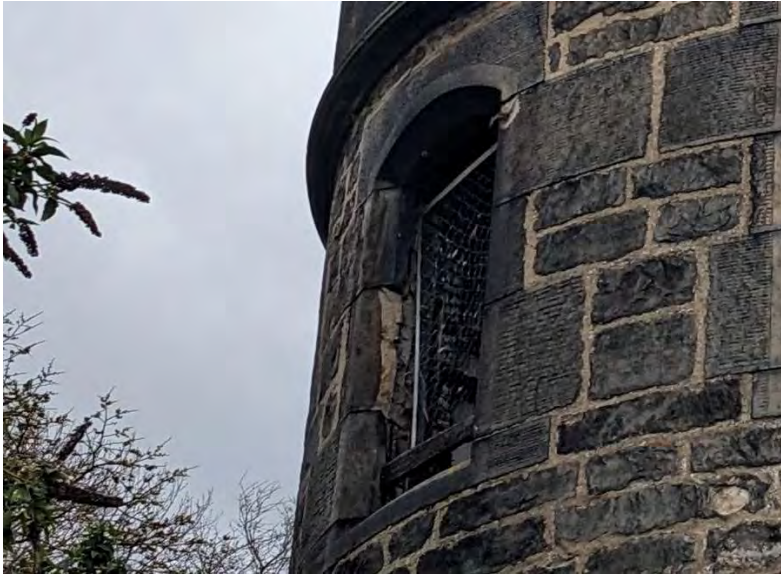
13

**Damaged masonry surrounding second floor window opening.**

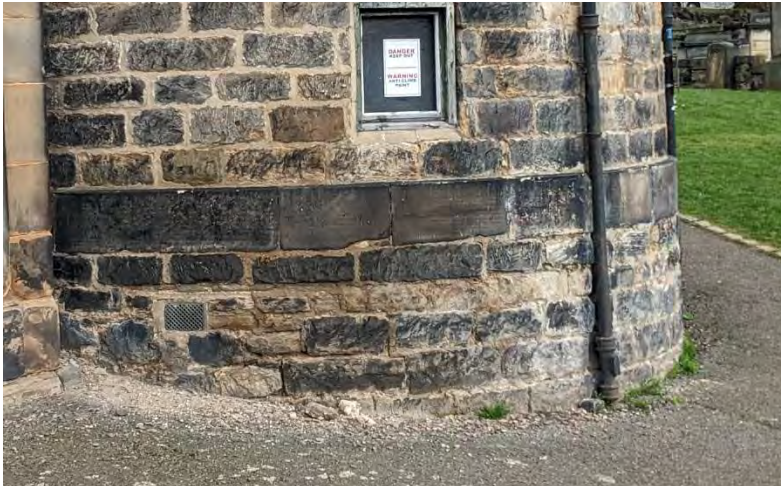
14

**Failing joints and localised eroded masonry immediately above ground level.**

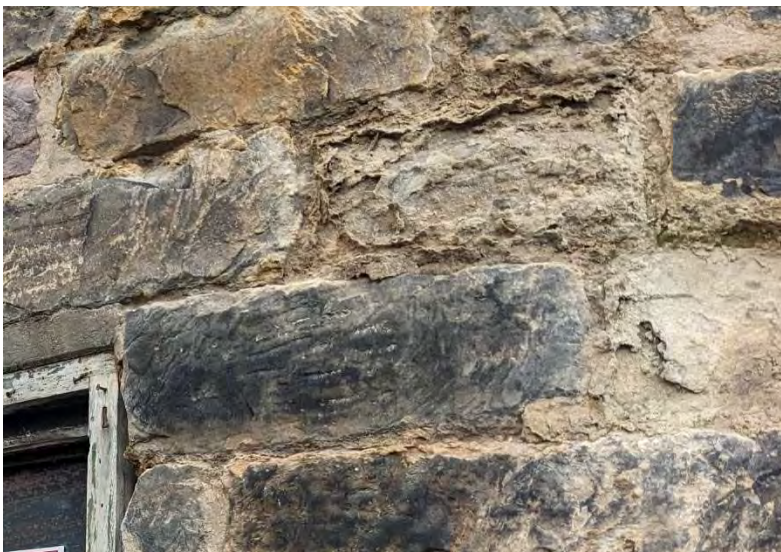
15

**Erosion may be exacerbated by the use of modern cement-based repair mortars.**

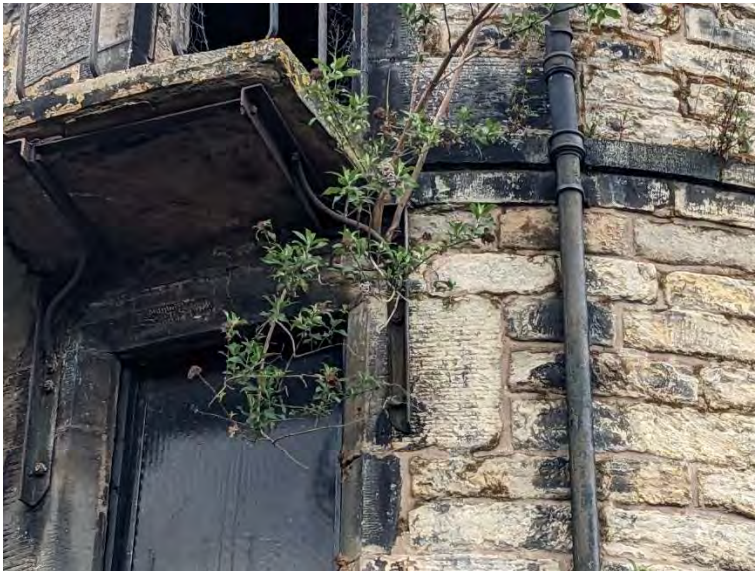
17

**Vegetation growth from masonry below the second floor entrance.**

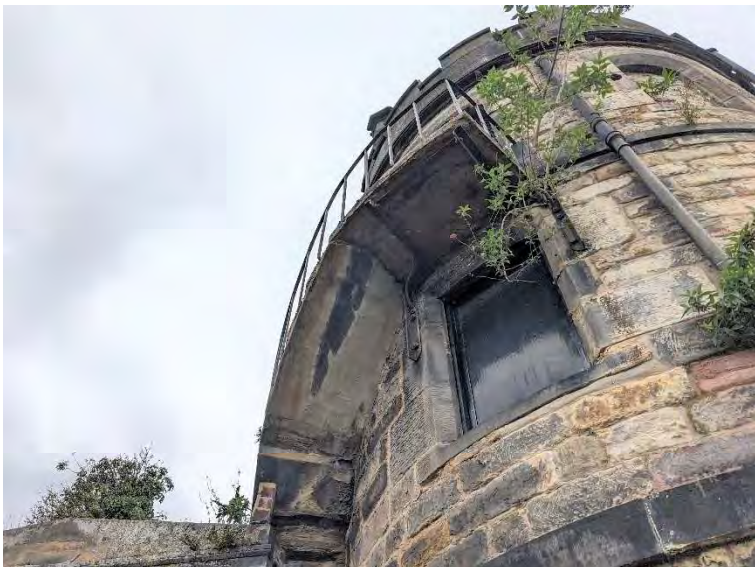
18

- 2.12 The external stair is in poor condition. Its stonework and the materials used in past repairs is deteriorating, with parts obviously becoming detached. There is a health and safety risk to anyone passing close by the south face of the building owing to the risk of material falling from the staircase. The stair has been repaired in the past, possibly on more than one occasion. These repairs include the application of cement-based toppings and facings, cement and stone indents, and possibly in one instance a whole replacement stone. Where toppings have been applied it is reasonable to assume that the top of the original stone has been cut back – certainly weathered away. It is not possible to know with any certainty how the structural integrity of the staircase has been affected – certainly, the robustness of its original construction will not be as good as it was originally. It should be assumed that the stair is now beyond reasonable repair and therefore complete replacement of all steps and landings should be anticipated. This work may be deferred if access to the staircase can be wholly prevented, however given the location of the building, preventing such access may prove difficult. The metal handrail is in poor condition. Furthermore, the wide spacing of balusters is a health and safety risk if future use is anticipated.

**Loose material should be removed from the underside of the external staircase and platt to reduce the risk of falling debris over publicly accessible areas.**

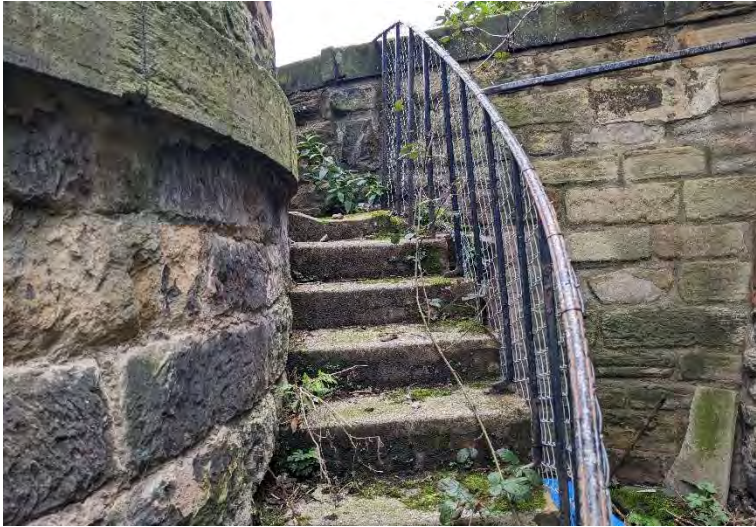
19

The external steps and landings have been repaired previously using a cement-based granolithic mix and other techniques. The repairs adopted would have been intrusive to the original fabric and difficult to reverse. Note vegetation growth. The treads seen here are carried by a dwarf wall – see Photo 21.

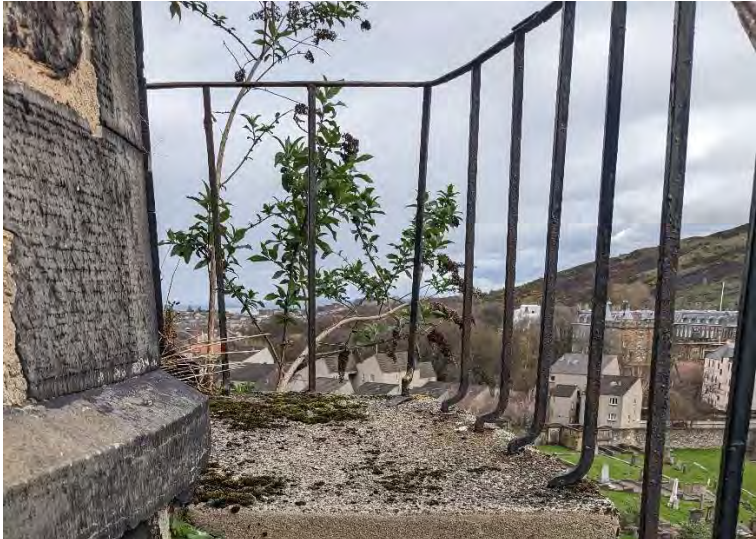
20

The metal handrail is in poor condition with widely spaced balusters.

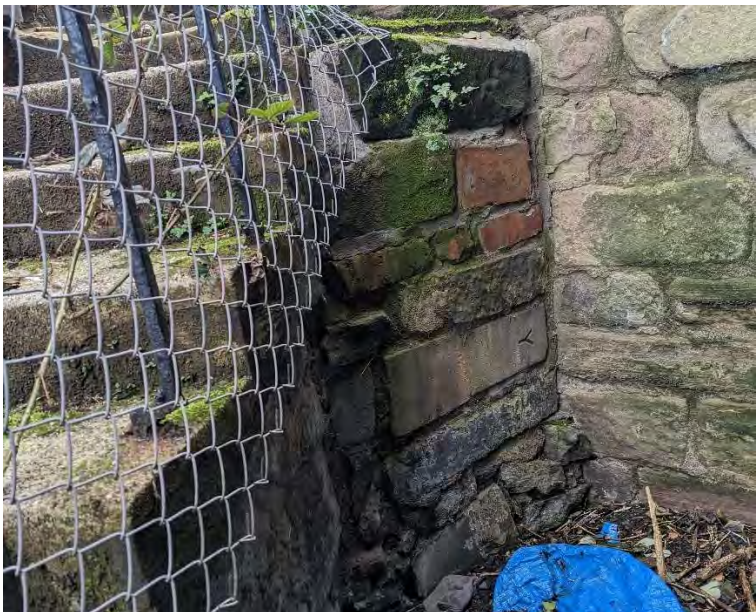
21

Localised failing joints to support masonry below steps leading to first floor level.

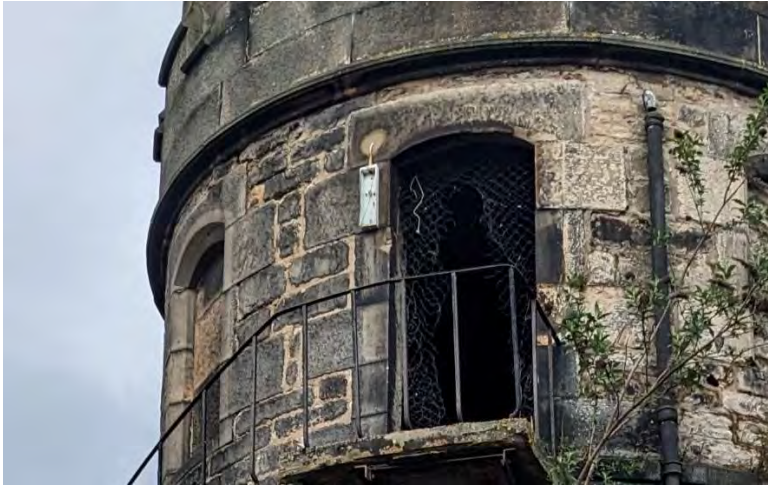
22

Failing mesh coverings to second floor openings are allowing birds to enter the property.

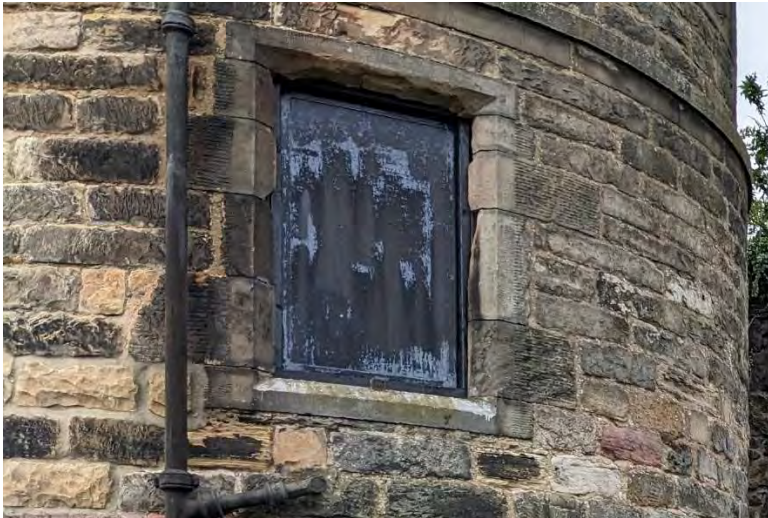
23

Although openings blocked up with metal sheeting and grilles are functional and prevent unauthorised entry, their appearance could be improved as part of future package of external repairs.

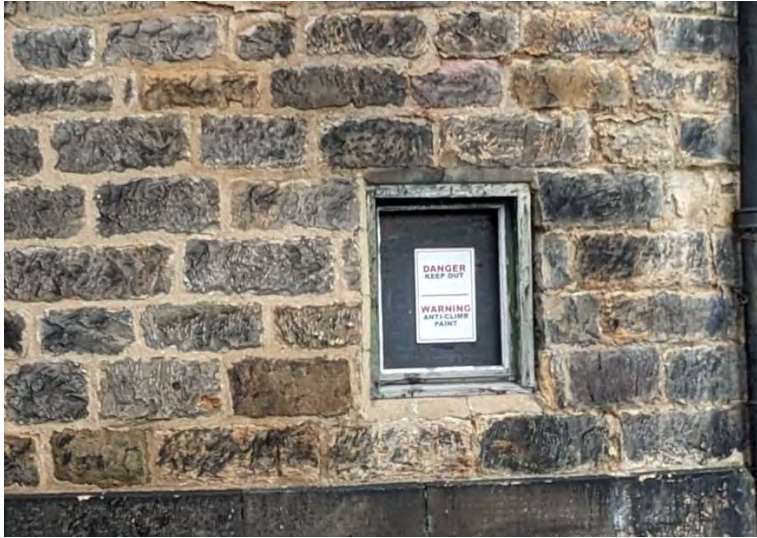
25

Rotten window frame at ground floor level.

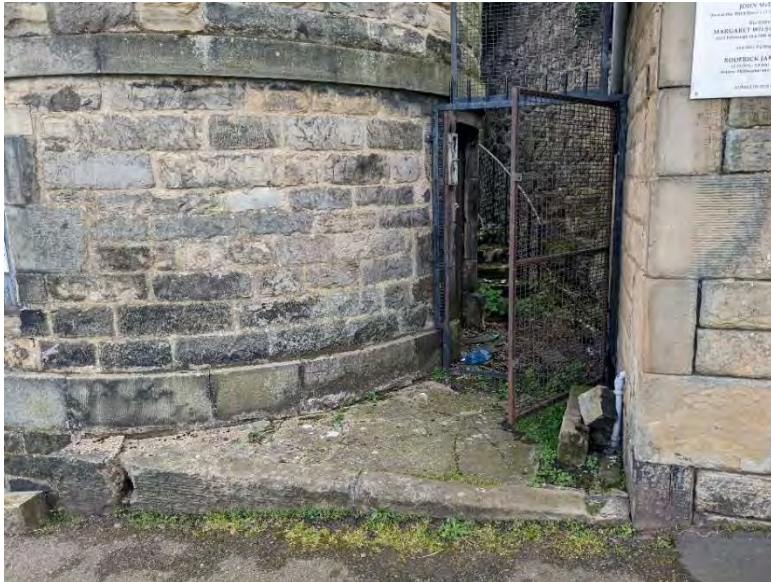
26

Damaged granolithic path and misaligned step leading to entrance.

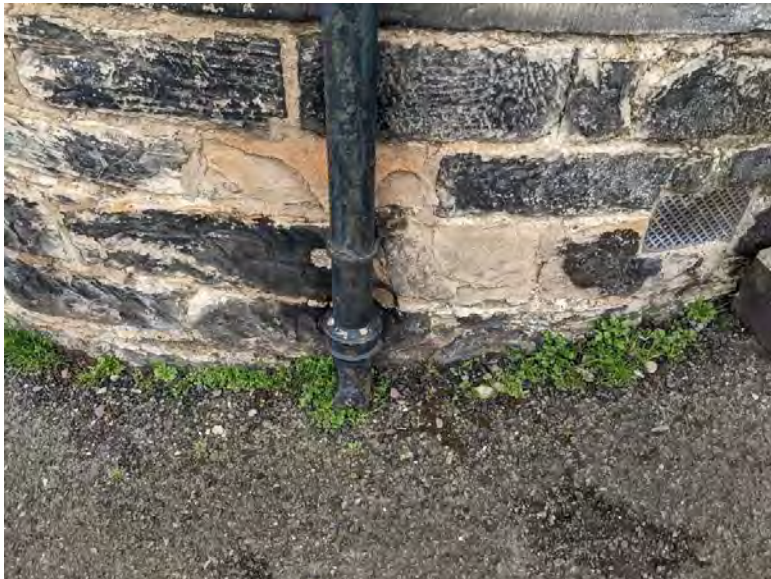
27

Access to waste pipe partially covered by tarmac. Note damaged masonry (see also Photo 15).

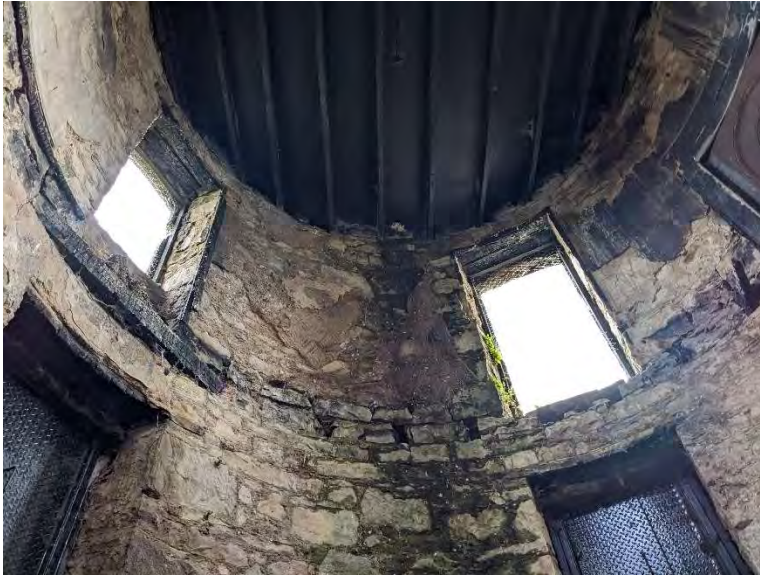
28

**Damp stained internal fabric from failing roof covering and blocked rainwater outlet.**

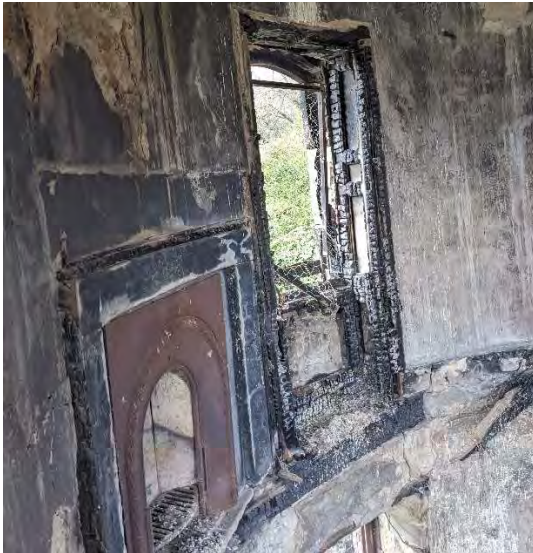
31

This fireplace is at 2<sup>nd</sup> floor level and is behind that part of the external wall seen in Photo 10. There is a fireplace beneath this one, at the (former) floor below.

See also Photos 10 and 11.

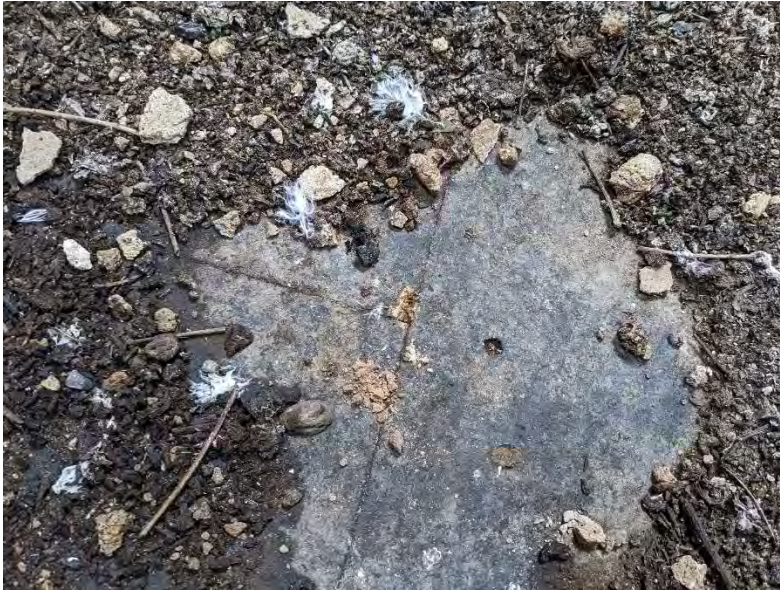
33

The chipboard floor installed in 2013 is in poor condition due to penetrating dampness and accumulated bird guano.

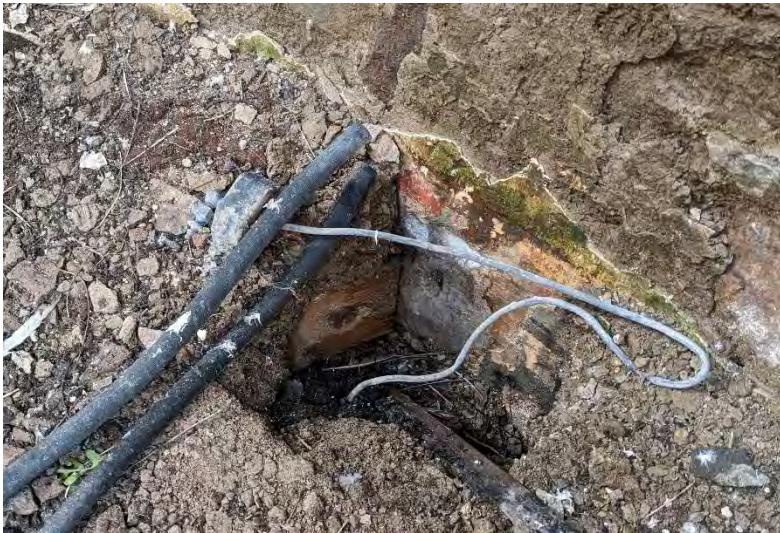
34

Damp stained floor joist. Note old gas light pipe.

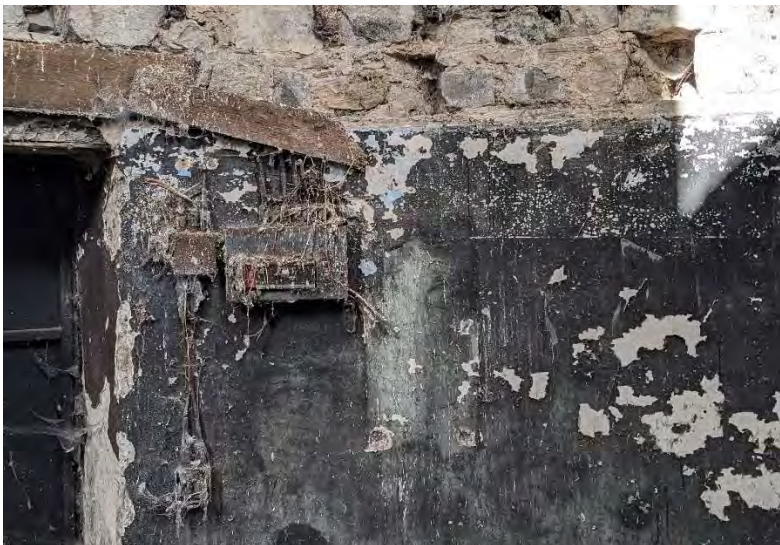
35

Aged electrical system.

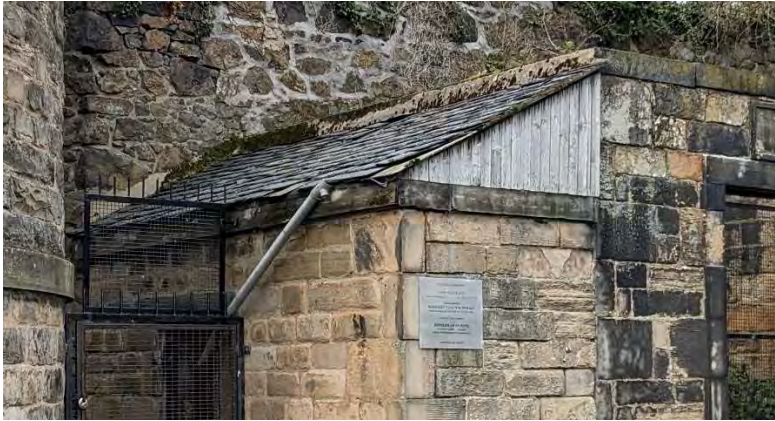
36

**Slipped and damaged slates and failing abutment mortar skew fillets.**

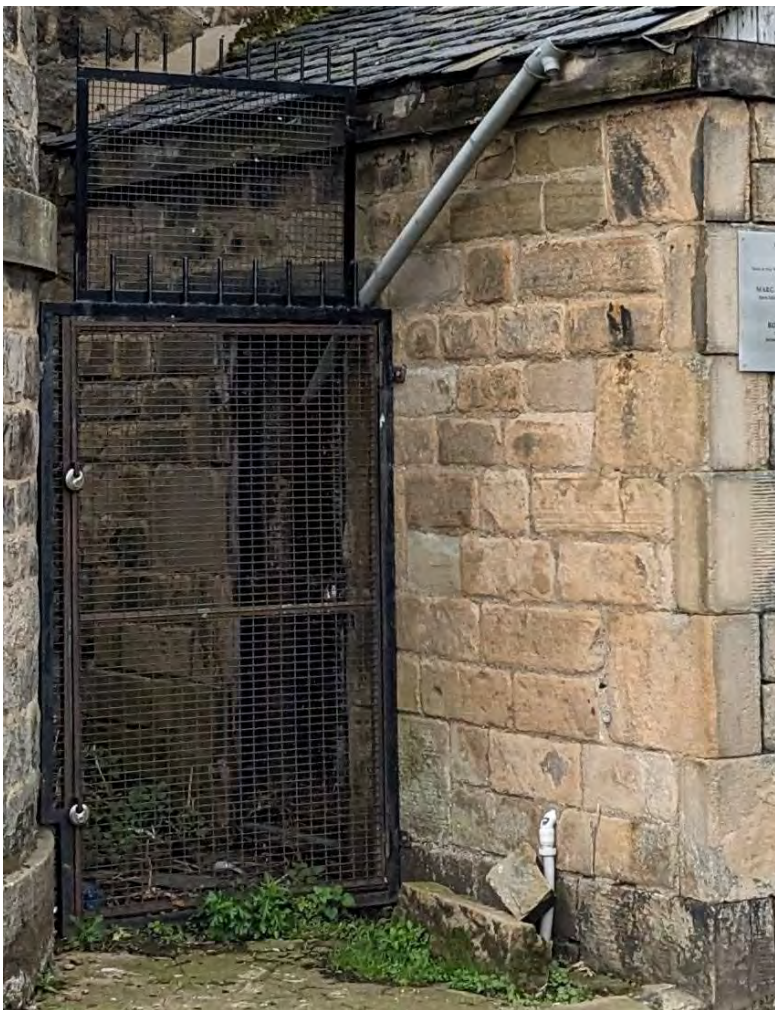
37

- 2.7 Failing uPVC rainwater goods and waste pipes to the adjacent outhouse should be replaced in cast iron.

**Failing rainwater goods and waste-water pipe on the south elevation. Note functional but visually obtrusive security gate.**

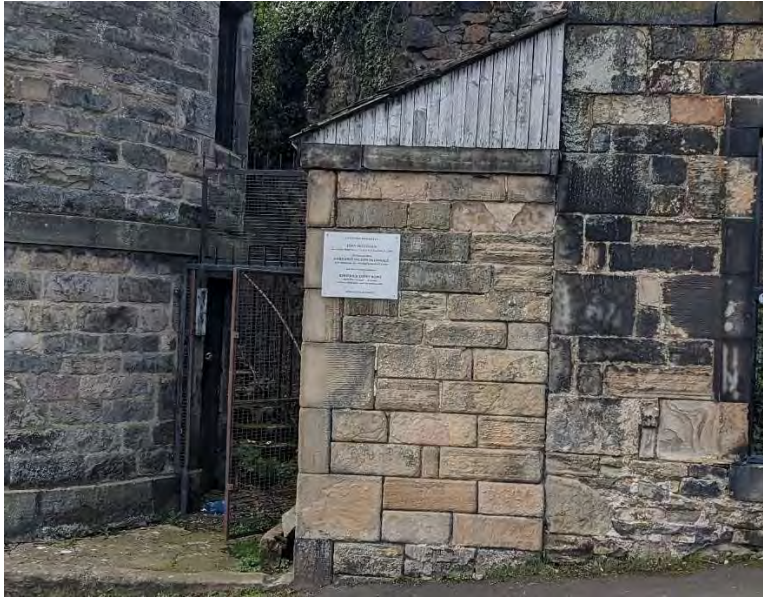
38

Failing mortar joints and localised stone erosion. Denatured timber above.

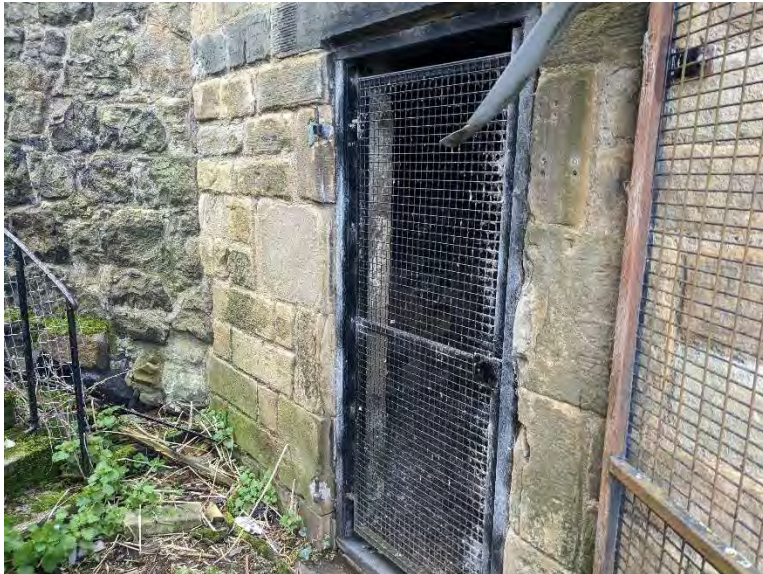
39

Damaged stonework to door surround and poor decoration to gate.

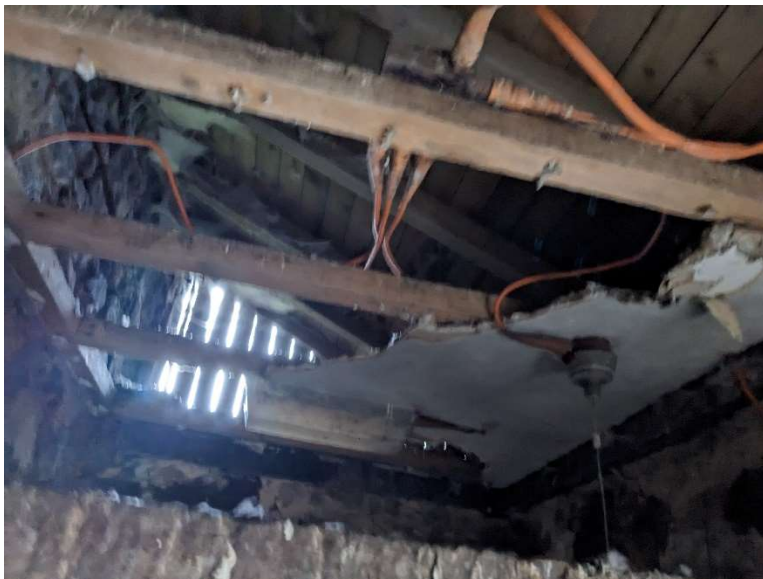
40

Collapsed ceiling.

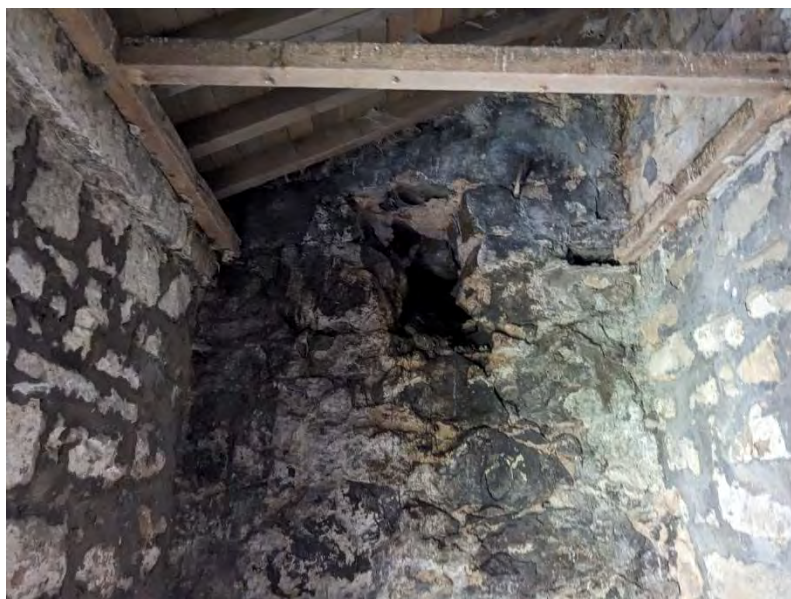
41

Holes in internal facing masonry and cement pointed joints.

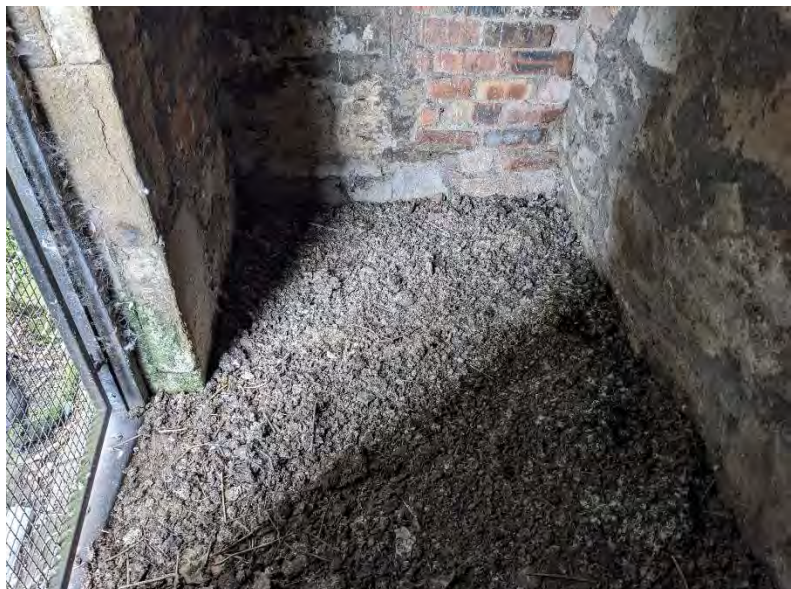
42

Guano covered floor.

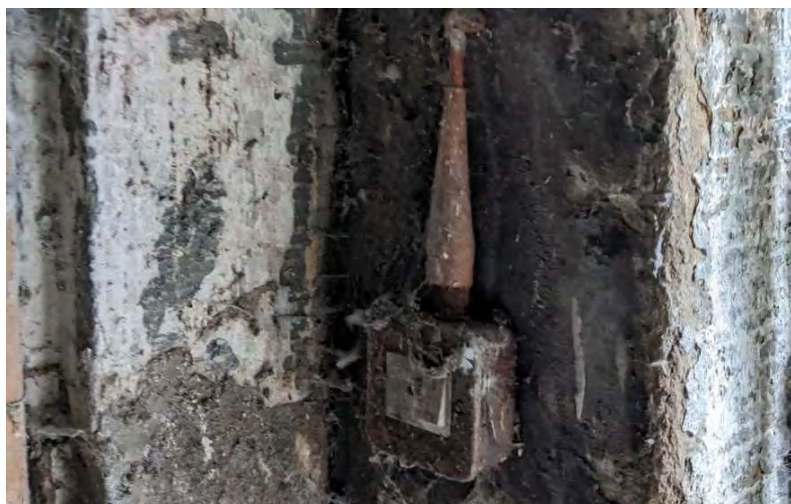
43

Aged electrics
