Transport and Environment Committee

Dell Road to Colinton Dell Access Path

Dell Road to Colinton Dell Path Closure

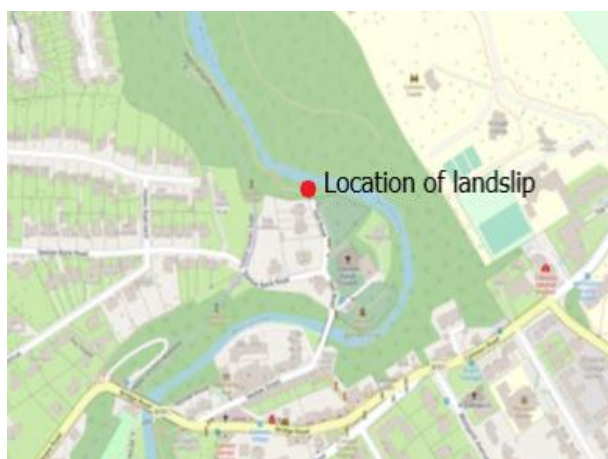
Figure 1

- 3.1 A section of slope on the bank of the Water of Leith within Colinton Dell failed in February 2020. The failure led to the movement of soil and vegetation downslope towards the watercourse and the toppling of a mature tree.
- 3.2 A period of prolonged cold wet weather along with wind speeds of over 60kph would likely have contributed to the conditions that led to the failure.
- 3.3 A short section of path, path supports, and metal safety railing were damaged. The location of the landslip is shown in figure 1 and 2.
