DRAWING TITLE: PLAN AS EXISTING/ PROPOSED ELEVATIONS AS EXISTING/ PROPOSED		Scale VARIES@A1	Issue status PA
Drawn CGY	Checked GF	Date 15/02/23	
PROJECT: MR & MRS FAVIER 19 INVERALMOND DRIVE EDINBURGH EH4 6JX		IN-AL(PA)01B

Client: Greg Favier

Location: 19 Inveralmond Drive,
Edinburgh, EH4 6JX

Surveyed: 19th July 2022

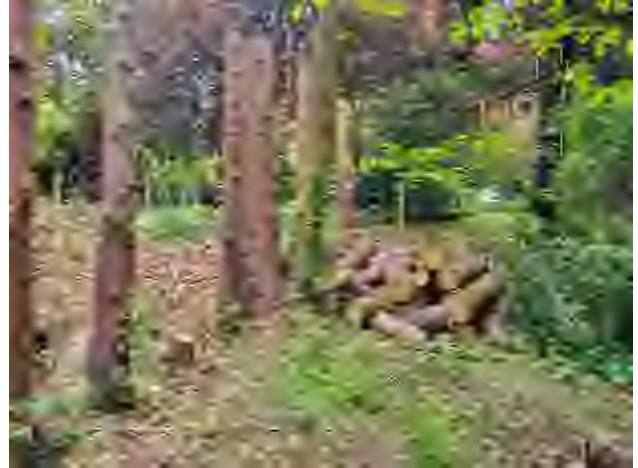
Tag Number:	T27
Common Name:	Lawson cypress
Latin Name:	Chamaecyparis lawsoniana
Tree Height [m]:	20
Number of Stems:	1
Stem Diameter [mm]:	400
(N) Branch Spread [m]:	1
(E) Branch Spread [m]:	1
(S) Branch Spread [m]:	1
(W) Branch Spread [m]:	1
Height of First Significant Branch [m]:	
Height of Canopy Above Ground Level [m]:	
Physiological Condition:	Fair
Structural Condition:	Fair
Quality Category:	C
Quality Sub-Category:	
Comments:	Another in the hedge line of the lawsons. Supressed canopy and poor choice of tree/ placement
Recommendations:	Remove
Works to be completed by:	
Estimated work hours:

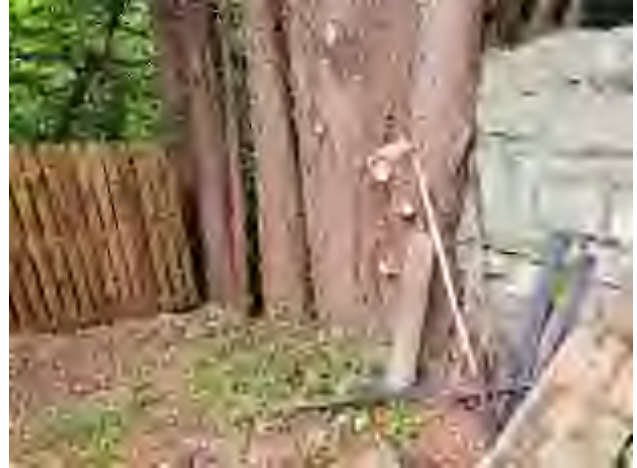
Lawson cypress Tree ID #29

Tree Details	
Tag Number:	T29
Common Name:	Lawson cypress
Latin Name:	Chamaecyparis lawsoniana
Tree Height [m]:	20
Number of Stems:	1
Stem Diameter [mm]:	450
(N) Branch Spread [m]:	4
(E) Branch Spread [m]:	0.5
(S) Branch Spread [m]:	2
(W) Branch Spread [m]:	6
Height of First Significant Branch [m]:	
Height of Canopy Above Ground Level [m]:	
Physiological Condition:	Fair
Structural Condition:	Fair
Quality Category:	C
Quality Sub-Category:	
Comments:	Tree is far enough away from house to surrounding structures that it can be left to grow
Recommendations:	Up to client whether or not to remove but not necessary as trees provide screening
Works to be completed by:	
Estimated work hours:

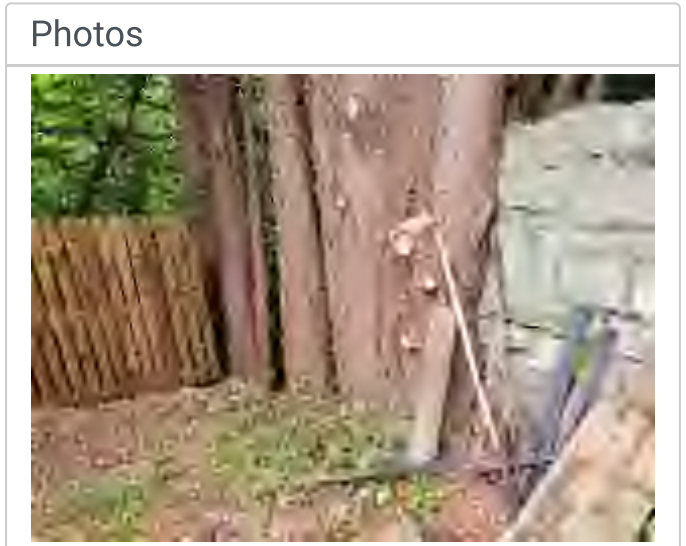
Lawson cypress Tree ID #30

Tree Details	
Tag Number:	T30
Common Name:	Lawson cypress
Latin Name:	Chamaecyparis lawsoniana
Tree Height [m]:	21
Number of Stems:	1
Stem Diameter [mm]:	450
(N) Branch Spread [m]:	2
(E) Branch Spread [m]:	2
(S) Branch Spread [m]:	2
(W) Branch Spread [m]:	2
Height of First Significant Branch [m]:	
Height of Canopy Above Ground Level [m]:	
Physiological Condition:	Fair
Structural Condition:	Fair
Quality Category:	C
Quality Sub-Category:	
Comments:	Last tree in line of overgrown screening. Canopy and tree leaning away from garden and adjacent structures
Recommendations:	Remove or keep for screening
Works to be completed by:	
Estimated work hours:

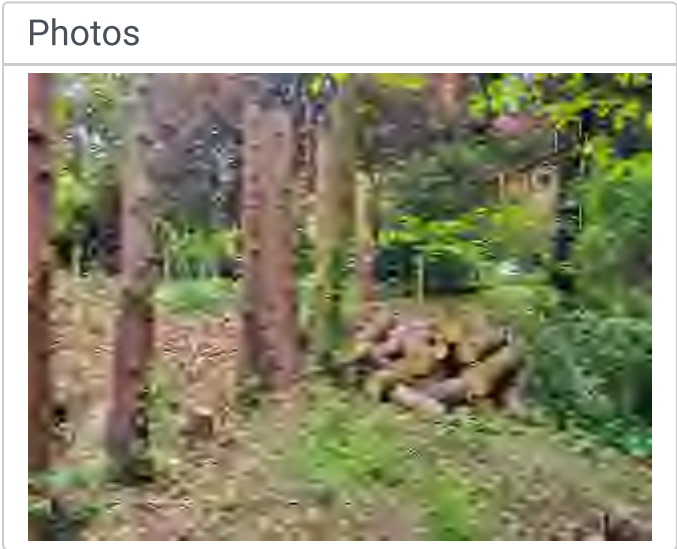
Common yew Tree ID #36
 21 Inveralmond Drive

Tree Details	
Tag Number:	T36
Common Name:	Common yew
Latin Name:	Taxus baccata
Tree Height [m]:	15
Number of Stems:	1
Stem Diameter [mm]:	350
(N) Branch Spread [m]:	3
(E) Branch Spread [m]:	5
(S) Branch Spread [m]:	3
(W) Branch Spread [m]:	5
Height of First Significant Branch [m]:	
Height of Canopy Above Ground Level [m]:	
Physiological Condition:	Fair
Structural Condition:	Fair
Quality Category:	C
Quality Sub-Category:	
Comments:	Large no. of dead branches Tree is being suppressed by neighbouring trees
Recommendations:	Deadwood. Speak to neighbour to see if they want it reduced over their garden while we are doing the work.
Works to be completed by:	
Estimated work hours:

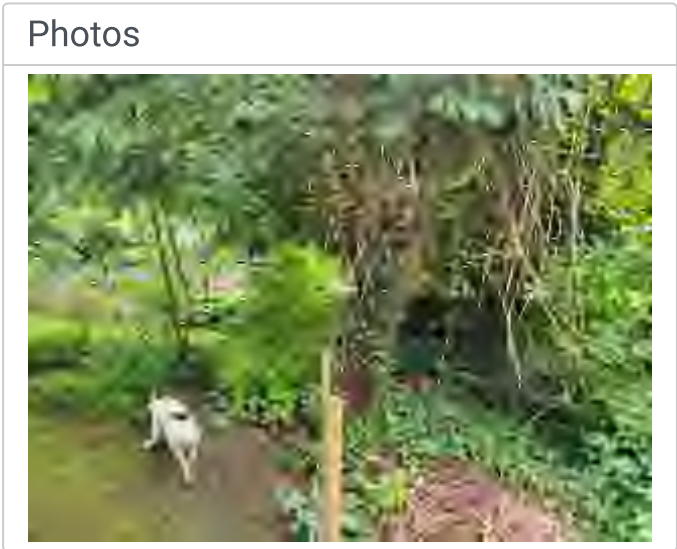
English elm Tree ID #37

Tree Details	
Tag Number:	T37
Common Name:	English elm
Latin Name:	Ulmus procera
Tree Height [m]:	18
Number of Stems:	2
Stem Diameter [mm]:	570.09
(N) Branch Spread [m]:	1
(E) Branch Spread [m]:	5
(S) Branch Spread [m]:	6
(W) Branch Spread [m]:	7
Height of First Significant Branch [m]:	
Height of Canopy Above Ground Level [m]:	
Physiological Condition:	Good
Structural Condition:	Fair
Quality Category:	B
Quality Sub-Category:	
Comments:	Included union between the two stems. large amount of sucker around base as is typical for this species
Recommendations:	Remove suckers and competition from stem. lift canopy to allow access. Remove stem
Works to be completed by:	
Estimated work hours:
