DRAWING TITLE: PLAN AS EXISTING/ PROPOSED ELEVATIONS AS EXISTING/ PROPOSED		Scale VARIES@A1	Issue status PA
Drawn CGY	Checked GF	Date 15/02/23	
PROJECT: MR & MRS FAVIER 19 INVERALMOND DRIVE EDINBURGH EH4 6JX		IN-AL(PA)01B

Client: Greg Favier

Location: 19 Inveralmond Drive,
Edinburgh, EH4 6JX

Surveyed: 19th July 2022

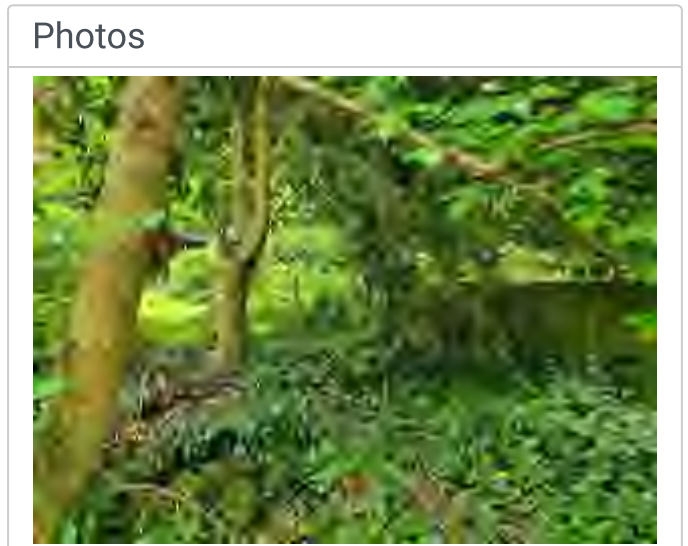
Common holly Tree ID #38

Tree Details	
Tag Number:	T39
Common Name:	Common holly
Latin Name:	Ilex aquifolium
Tree Height [m]:	12
Number of Stems:	1
Stem Diameter [mm]:	350
(N) Branch Spread [m]:	4
(E) Branch Spread [m]:	3
(S) Branch Spread [m]:	3
(W) Branch Spread [m]:	4
Height of First Significant Branch [m]:	
Height of Canopy Above Ground Level [m]:	
Physiological Condition:	Fair
Structural Condition:	Fair
Quality Category:	B
Quality Sub-Category:	
Comments:	Tree has been pollarded in past at 1.5m. Lapped pollards as a result and as a result most likely some decay. Tree leans over wall and neighbours property
Recommendations:	Reinspect
Works to be completed by:	
Estimated work hours:
