Subject: Re: Tree advice 19 Inveralmond Drive

TD Tree & Land Services Ltd have been instructed by Mr. Gregory Favier to carry out a survey at 19 Inveralment Drive, Edinburgh, EH4 6JX and produce a report on the Arboricultural impacts in accordance with British Standard BS:5837 Trees in relation to Design, Demolition and Construction – Recommendations.

Tree Survey

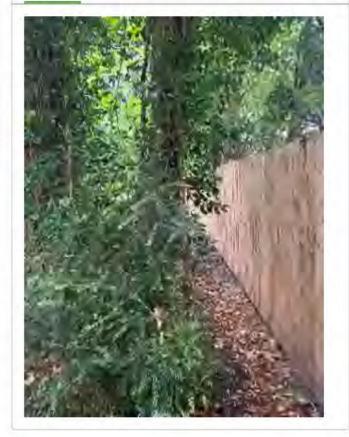
Sycamore Tree ID #5 20 Avon Road

T5	Sycamore	Acer pseudo- platanus	15	624.82	7.5	5	8	2	3	3	w	12	Semi- mature	Fair	Fair	Medium (20 to 40 years)	lvy covering stem, eastern stem showing large section of decay at base up to approx. 2m height	С	1
T6	Japanese Ce- dar	Cryptomeria ja- ponica	9	190	2,28	3	2	1	2	0	NE	9	Young	Good	Good	Long (>40 years)	Overall fair condition	С	1

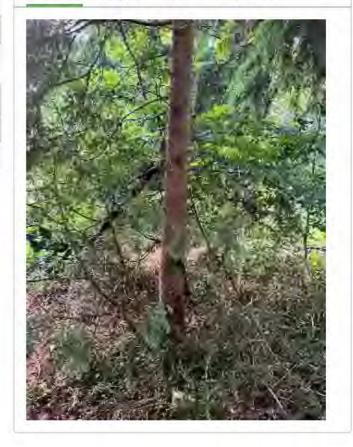
Western Hemlock Tree ID #7

17	Western Hemlock	Tsuga hetero- phylla	19	1050	12.6	8	8	7	8	2	E	17	Mature	Good	Good	Medium (20 to 40 years)	mature specimen, high amenity value and of good arboricul- tural value	A	1, 2
T8	Leylandii	Cupressus x ley- landii	7	180	2.16	3	2	1	2	0	E	7	Young	Good	Fair	Long (>40 years)	Overall fair condition	С	1
T9	Norway Ma- ple	Acer plat- anoides	7	120	1.44	3	2	0	1	1.5	N	5,5	Young	Good	Fair	Long (>40 years)	Overall fair condition	c	1
T10	Hawthorn	Crataegus mo- nogyna	9	210	2.52	3	3	2	3	2.5	N	16.5	Early- mature	Fair	Fair	Medium (20 to 40 years)	Overall fair condition	C	1
T11	Common Holly	llex aquifolium	12	220	2.64	4	3	3	3	3	E	9	Early- mature	Fair	Fair	Medium (20 to 40 years)	Overall fair condition	В	2
T12	Norway Ma- ple	Acer plat- anoides	16	380	4.56	3	5	6	4	2.5	SE	13,5	Early- mature	Fair	Fair	Medium (20 to 40 years)	Overall fair condition	B	2
T13	Leylandii	Cupressus x ley-	250	210	2.52	0.5	0.5	0.5	0.5				Early- mature	Dead	Poor	Very Short (<10 years)	monolith	ú

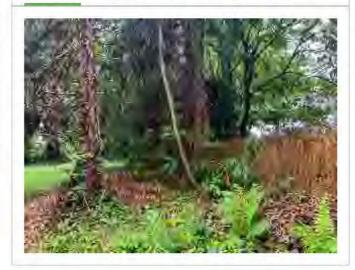
Leylandii Tree ID #13

Tree T13 is a standing dead habitat pole, however, due to site safety, its removal is recommended. The stem may be cut up to form a dead wood pile on site, to still serve as habitat for a variety of species.
